Assessment of
Banda Aceh, Sumatra, Indonesia
following the earthquake and
tsunami of 26th December 2004

Tsunami Safe Hills &
Other interested parties

March 2005

Ref:- Report v2

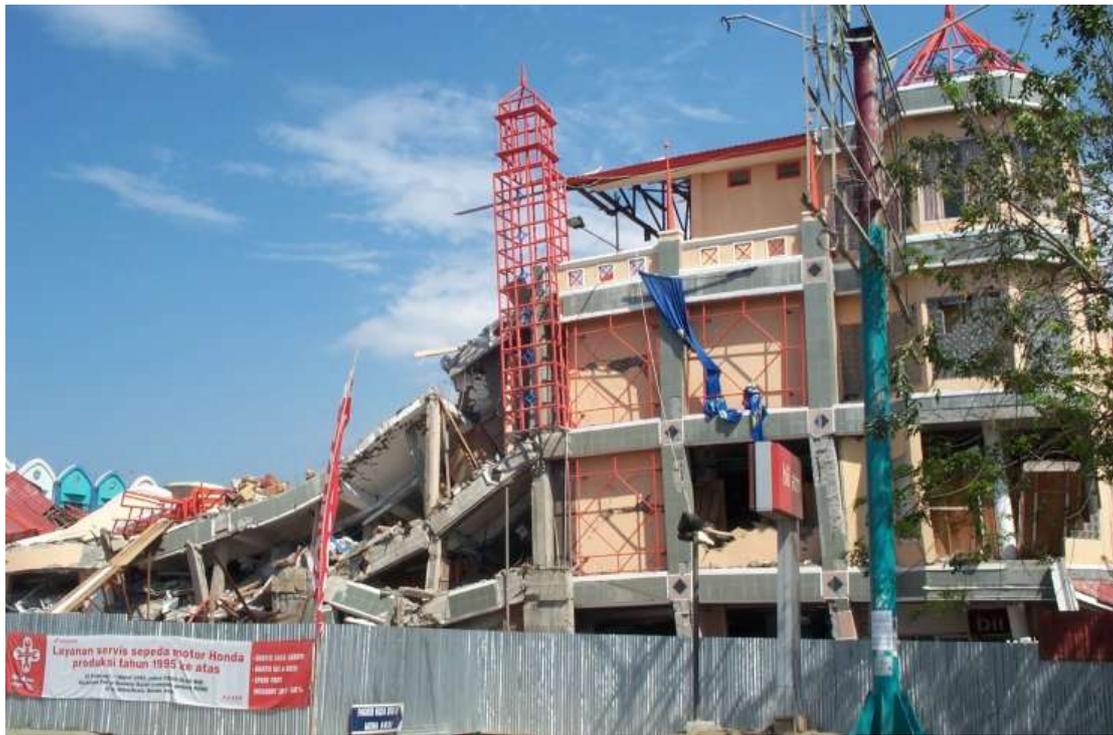
The earthquake conspicuously damaged a number of buildings in the city of Banda Aceh, possibly up to 10% of buildings suffered extensive damage. Due to the subsequent tsunami it is not possible to determine precisely the quantity of damaged buildings alone, since the tsunami also caused extensive damage. Damage varied from notional cracking, to failure of sections of buildings, to complete destruction. Some collapsed buildings were suspected to still contain victims.

Shopping Mall extensively damaged Banda Aceh

Owing to the scale of devastation some of the buildings I saw were still structurally unstable and either partial or complete demolition is recommended. In view of the seismic activity of the area this work should be completed as soon as practically possible.

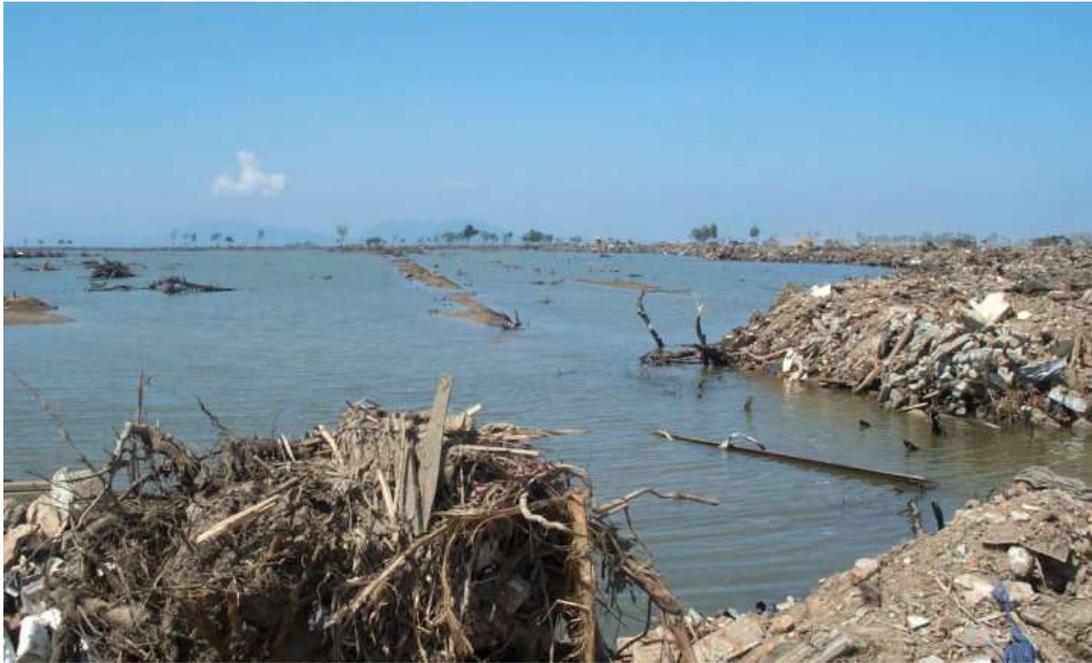
Deposited debris Banda Aceh

The debris present in the water reduced the ability of people in the water to swim or attempt coordinated movements. The debris, which was deposited after the tsunami water subsided, also hindered the initial emergency response, as it blocked roads, covered bodies, prevented proper drainage and generally reduced movement. In addition removal of the debris also was an important component of daily activities in the beginning of the reconstruction period. Since debris may be deposited up to 1m deep in places, some of the debris may still contain human remains.

Some of the debris may be used (after an initial sorting) in creating *Tsunami Safe Hills* or other elevated structures designed to cope with potential tsunami affects.

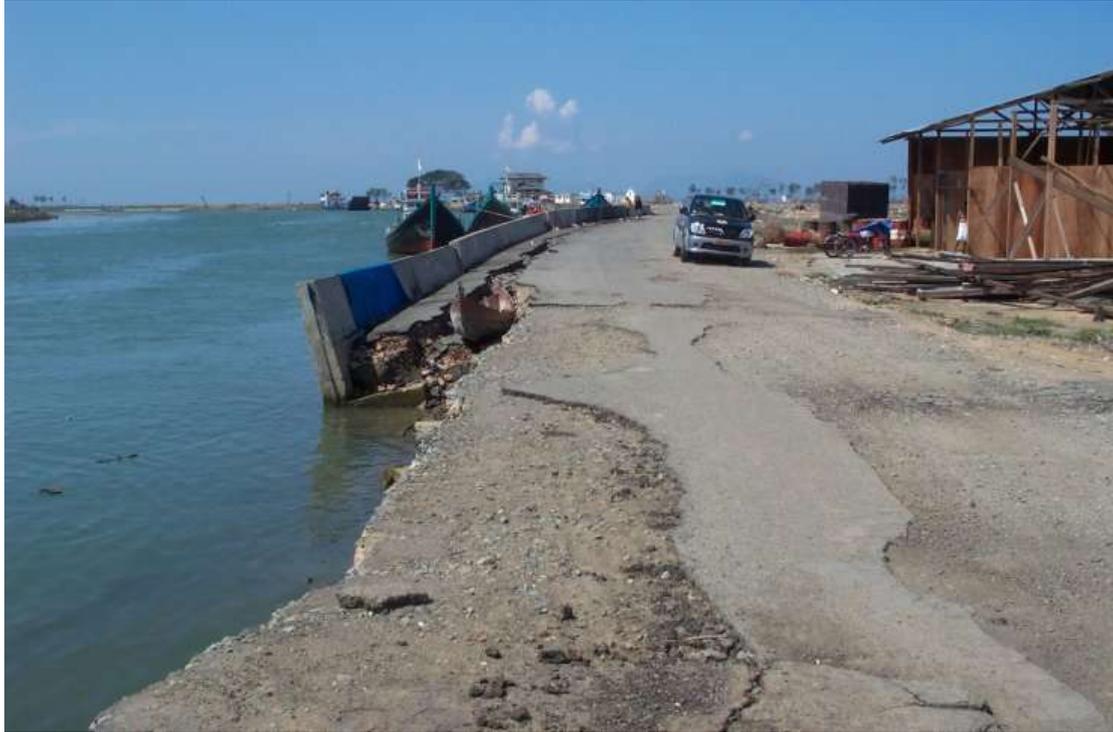
Most main roads have now been cleared of debris, so that most vehicles can travel without too much difficulty. Some minor roads have not been cleared of material and are not defined. Occasionally new tracks have been formed where appropriate. Some roads have been damaged or destroyed, particularly those sections near the most devastated areas of Banda Aceh.

Road and flood barrier damaged Banda Aceh

The height of flood barriers (walls and embankments) was in general, significantly exceeded by the tsunami. Only a small number of flood prevention structures were studied. However, floodwalls of reinforced concrete were noted to have been partially successful in withstanding the earthquake and tsunami. Earth embankment structures were less successful and most were observed to have been obliterated beyond recognition.

In order for a suitable response to future tsunami all roads should permit freedom of movement, so that evacuations may be carried out as efficiently as possible.

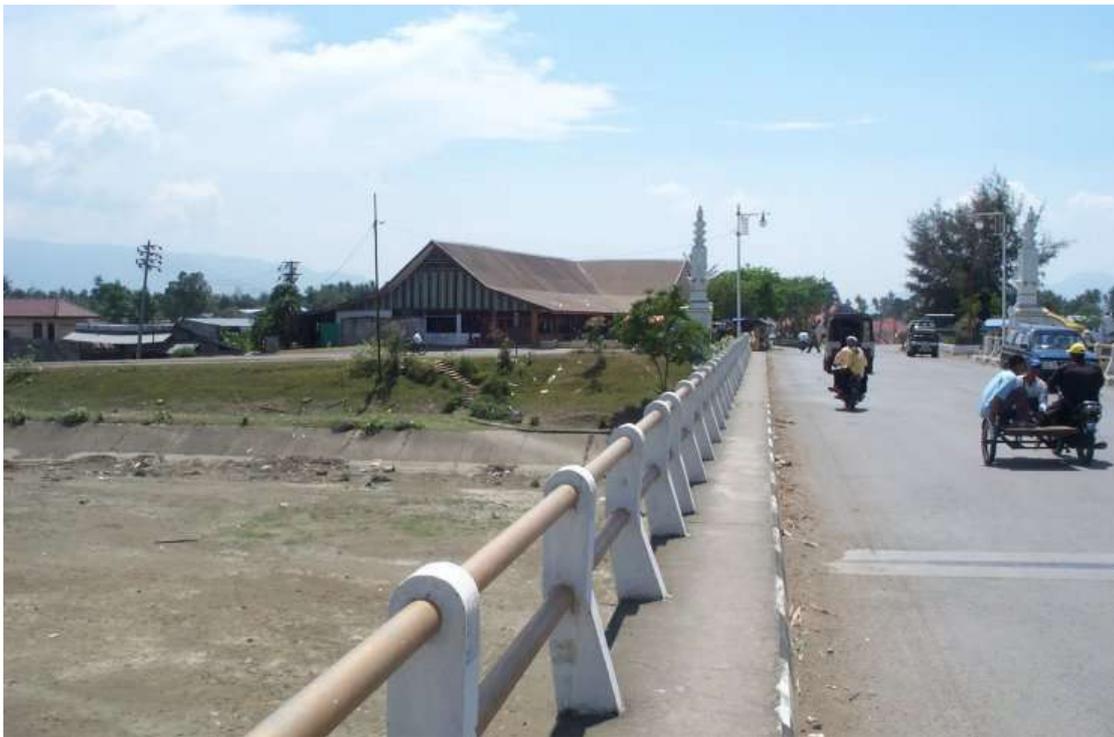
Most main roads have connecting bridges over land drainage channels. These bridges are higher than adjacent areas, some offered refuge areas to people nearby. Some bridges suffered some cracking and widening over the expansion joints. Occasional bridge sections were destroyed, although most were able to withstand the tsunami.

Bridges structures were able to withstand the combined earthquake and tsunami affects most effectively. Most bridge abutments have been able to withstand tsunami scour, whilst easily coping with the earthquake vibrations. The bridges themselves have been able to move slightly during the earthquake (with minor widening of expansion joints) while permitting the flow of water either beneath or through the structure proper although some bridge decks failed, probably as a result of debris causing displacement by hydraulic forces.

Bridge Banda Aceh

Any future development of bridge structures should reflect their inherent ability to function either during or after the tsunami event. Preferably all new bridges should be constructed above the height of the tsunami water level, so that they may also serve as emergency safe areas during a future tsunami.

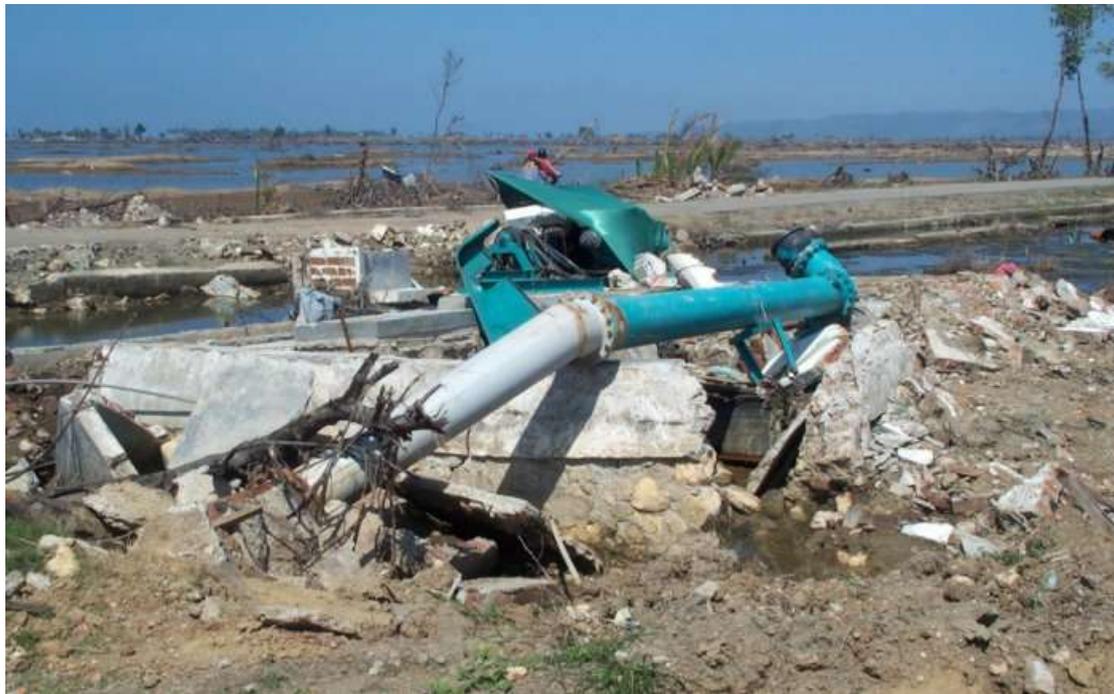
Pumping Station Banda Aceh

A single pumping station was observed during the survey, which was extensively damaged. It is unlikely that the pumping station could be repaired. Gravity sluices gates performed better, some appearing in good order, with others clearly damaged.

Flood prevention mechanisms should be comprehensively assessed and reinstated prior to major reconstruction phases.

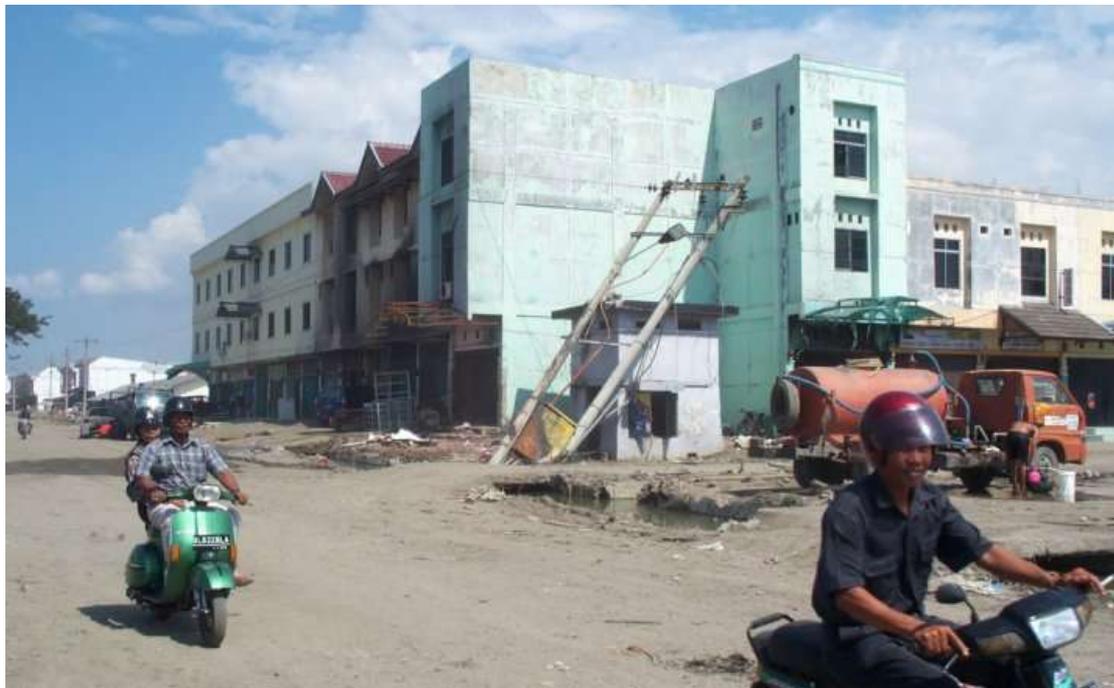
Electric and water supplies Banda Aceh

Water supply has been contaminated, by seawater and debris, with some pipelines damaged. Therefore a significant portion of the city does not have a piped water supply. Mobile water tanker provided water supplies where appropriate.

Most electrical supplies are distributed from overhead power cables, with very few underground cables being used. A significant portion of the city does not possess any electrical supply, and night illumination levels are correspondingly low.

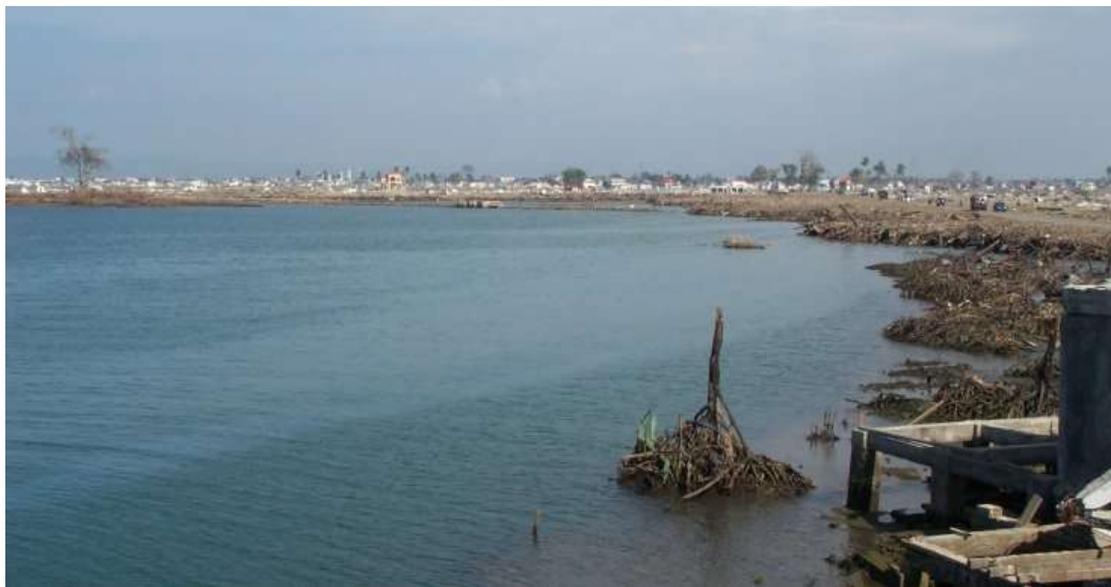
Most of the mangrove forests observed were completely destroyed, with only occasional root structures remaining. It has been suggested that the presence of mangrove forests could potentially reduce the impact of tsunami. No evidence was observed that mangrove forests reduced or increased the impact of the tsunami.

The remains of mangrove forests Banda Aceh

However, it would be prudent to permit the establishment of mangrove forests in low level areas, as the presence would prevent or reduce residential development, and enhance the local environmental features.
